National Highway Traffic Safety Administration

ON-SITE AIR BAG INVESTIGATION

CASE NO. - 96-12 FLEET - PRIVATE VEHICLE LOCATION - NORTH CAROLINA ACCIDENT DATE - 1996

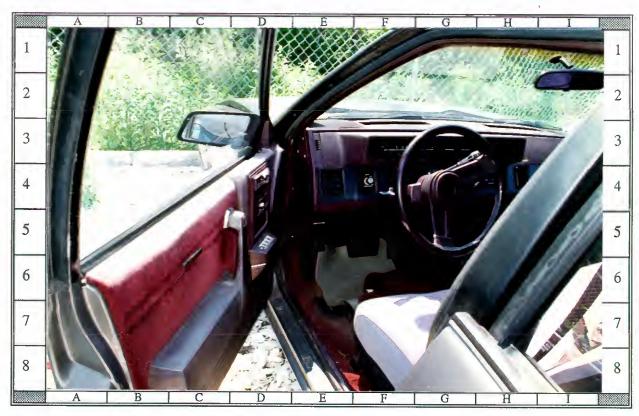
83: Interior surface of Vehicle #2's driver door panel, steering wheel, and front dash area viewed from outside driver's door; NOTE: no evidence of contact

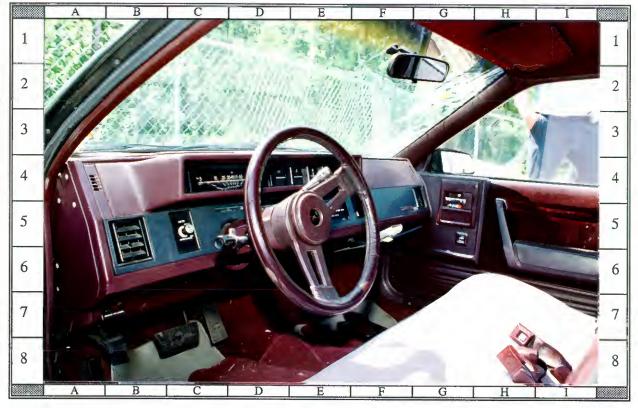
84: Vehicle #2's front seating area, steering wheel, and dash; NOTE: contacts to right side of windshield and dash from driver

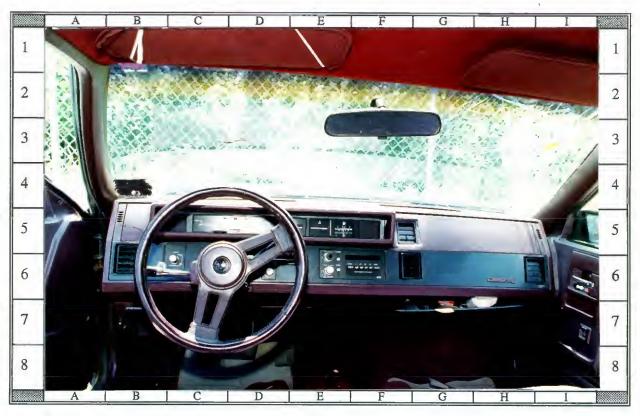
85: Vehicle #2's steering wheel, front dash, rearview mirror, windshield and header area viewed from rear center seat

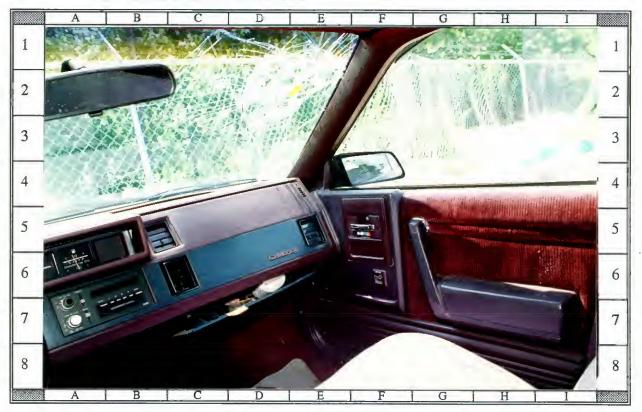
86: Vehicle #2's contacted right windshield and lower dash; NOTE: driver was unbelted and thrown towards 2 o'clock PDOF

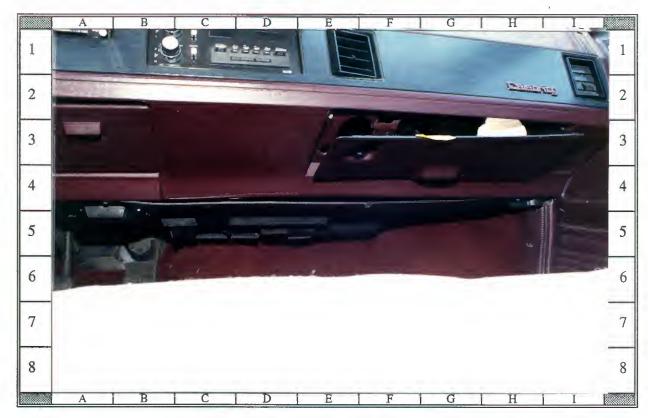
#87: Close-up of Vehicle #2's broken glovebox from driver contact

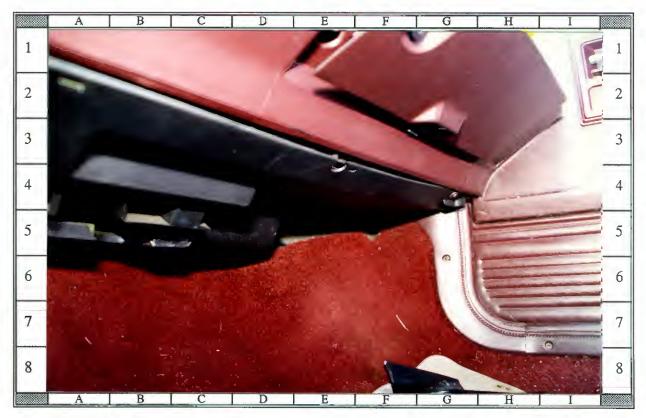
88: Close-up of Vehicle #2's toepan area showing minor intrusion

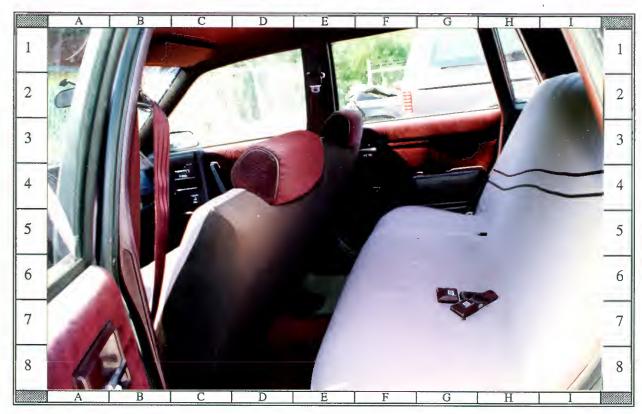
89: Vehicle #2's rear seating area; NOTE: front seat headrests and outboard, 3-point safety belts, and three, 2-point, lap belts in rear seating area

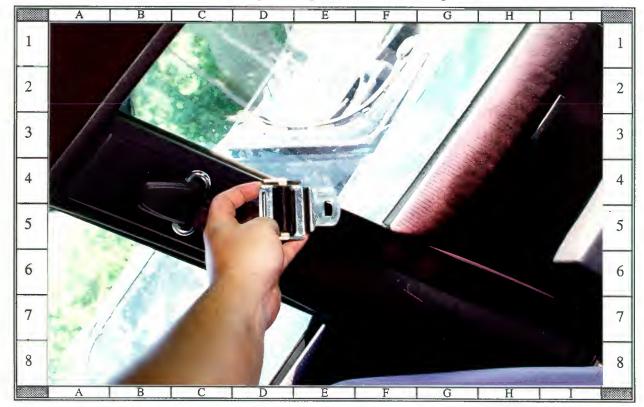
90: Vehicle #2's driver seatbelt showing signs of previous usage
